**Flood Control Project Maintenance
Levee Inspections**

Maintenance Issue Types Only, Levee Inspection Report By Mile - Fall 2014

Levee District No. 0001 (Glenn County)

Waterway	Bank	Unit Miles	Inspection Start/End	Inspector
Unit No. 01 Sacramento River	Right	12.23	10/30/2014 10/30/2014	Bob Duffey

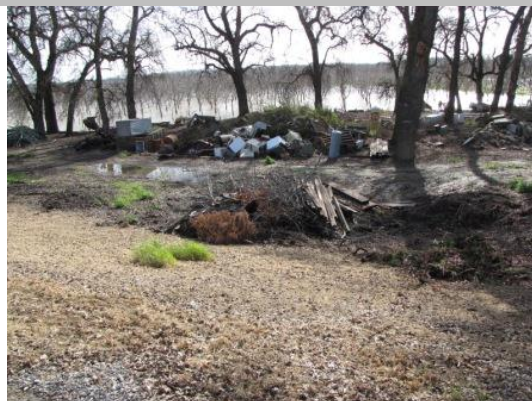
Photo 1 of 1 : FA_2014_LD0001G_432_1_20141013_00001.jpg

LM Start	1.23	Rating **	M	Issue No.	1
LM End	1.23	Issue Type +	Ma	Location *	WS
Category	Earthen Levee			GPS Latitude/Longitude	
				Start	End
Item	Encroachments			39.493423 °	39.493423 °
				-122.018885 °	-122.018885 °
DWR ID	DWR_LD0001G_01_s_2012_1				
Action/Comments					
Debris

View of the debris & garbage along the W/S toe.

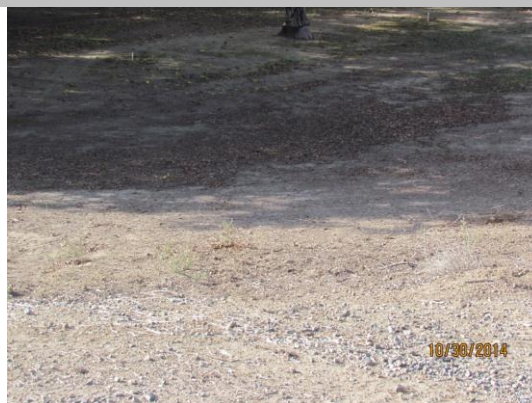
Photo 1 of 1 : FA_2014_LD0001G_432_50_20141121_00041.jpg

LM Start	2.86	Rating **	A/W	Issue No.	50
LM End	2.86	Issue Type +	Ma	Location *	LS
Category	Earthen Levee			GPS Latitude/Longitude	
				Start	End
Item	Animal Control			39.509503 °	39.509503 °
				-122.008732 °	-122.008732 °
DWR ID	DWR_LD0001G_01_f_2014_50				
Action/Comments					
No rodents visible, but rodent burrows visible; need to backfill and compact or grout burrows.

View of the rodent activity along the landside slope.

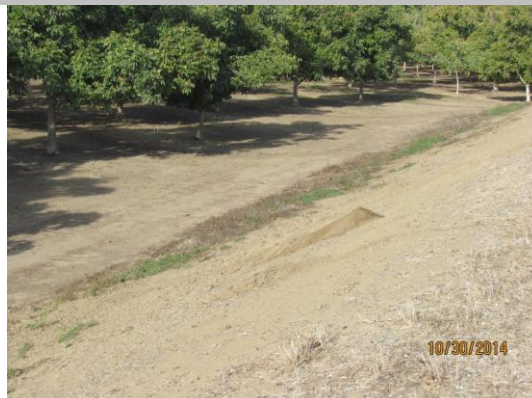
Photo 1 of 1 : FA_2014_LD0001G_432_51_20141121_00043.jpg

LM Start	3.15	Rating **	M	Issue No.	51
LM End	3.15	Issue Type +	Ma	Location *	N/A
Category	Earthen Levee			GPS Latitude/Longitude	
				Start	End
Item	Animal Control			39.513485 °	39.513485 °
				-122.009593 °	-122.009593 °
DWR ID	DWR_LD0001G_01_f_2014_51				
Action/Comments					
No rodents visible, but rodent burrows visible; need to backfill and compact or grout burrows.

View of the rodent activity along the landside slope.

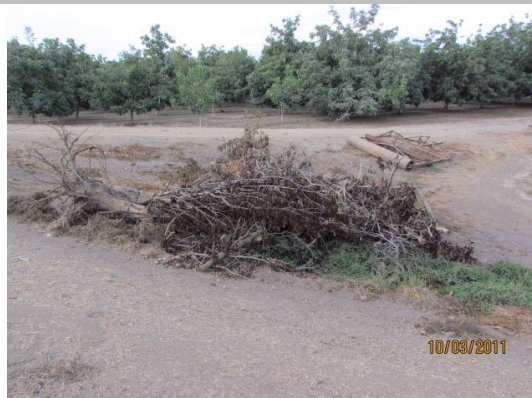
Photo 1 of 1 : FA_2014_LD0001G_432_16_20141013_00009.jpg

LM Start	3.22	Rating **	M	Issue No.	16
LM End	3.22	Issue Type +	Ma	Location *	LS
Category	Earthen Levee			GPS Latitude/Longitude	
				Start	End
Item	Encroachments			39.514378 °	39.514378 °
				-122.010306 °	-122.010306 °
DWR ID	DWR_LD0001G_01_s_2012_16				
Action/Comments					
Prunings

View of the pruning pile along the L/S toe.

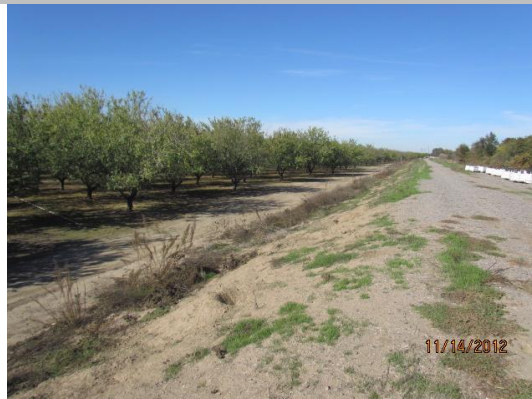
Photo 1 of 1 : FA_2014_LD0001G_432_7_20141013_00004.jpg

LM Start	5.16	Rating **	A/W	Issue No.	7
LM End	5.23	Issue Type +	Ma	Location *	LS
Category	Earthen Levee			GPS Latitude/Longitude	
				Start	End
Item	Animal Control			39.534741 °	39.535738 °
				-121.996024 °	-121.996570 °
DWR ID	DWR_LD0001G_01_f_2012_7				
Action/Comments					
No rodents visible, but rodent burrows visible; need to backfill and compact or grout burrows.

View of the rodent hole along the levee slope.

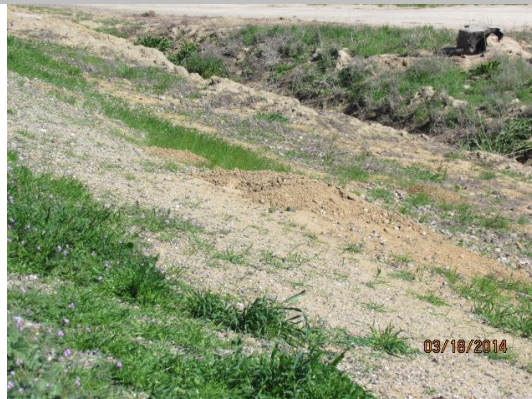
Photo 1 of 1 : FA_2014_LD0001G_432_48_20141013_00015.jpg

LM Start	11.70	Rating **	M	Issue No.	48
LM End	11.70	Issue Type +	Ma	Location *	WS
Category	Earthen Levee			GPS Latitude/Longitude	
				Start	End
Item	Animal Control			39.622652 °	39.622652 °
				-121.999185 °	-121.999185 °
DWR ID	DWR_LD0001G_01_s _ 2014_48				
Action/Comments					
No rodents visible, but rodent burrows visible; need to backfill and compact or grout burrows.

View of the rodent activity along the w/s slope.
